# **Study of Slope Instability of Nablus – Al-Bathan Road**

**Stations 2+100**

Construction and Transportation Research Unit  
Urban Planning and Disaster Risk Reduction Center  
An-Najah National University

**June 2012**

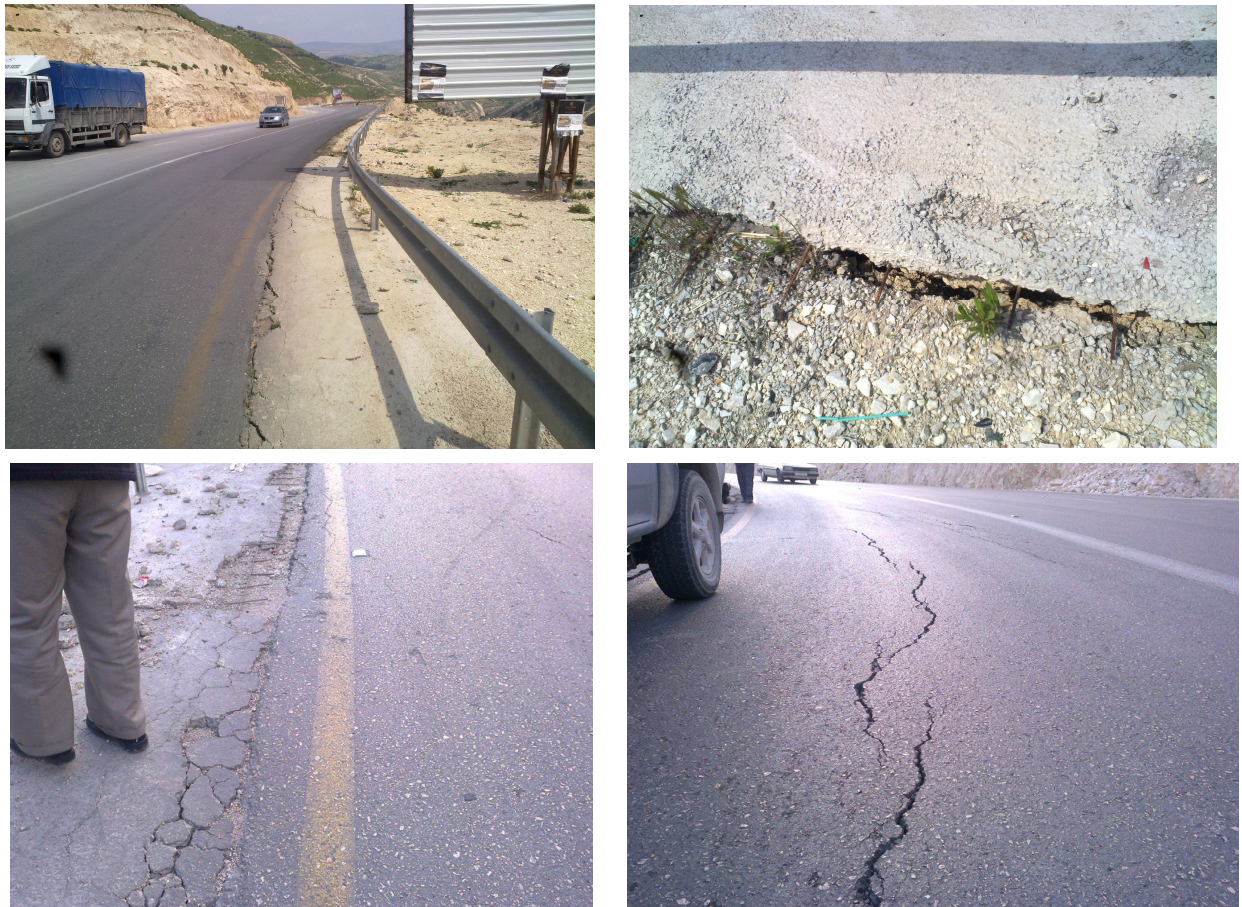
Based on visual observations, every year Nablus – Al-Bathan road suffers longitudinal cracks in several places along the eastern side of the road, as shown in Figure 1. In addition to that local lands sliding along the eastern and western sides are usually observed yearly, as shown in Figure 2.

**Figure 1: Typical cracks that occurs yearly along Nablus – Al-Bathan Road.**

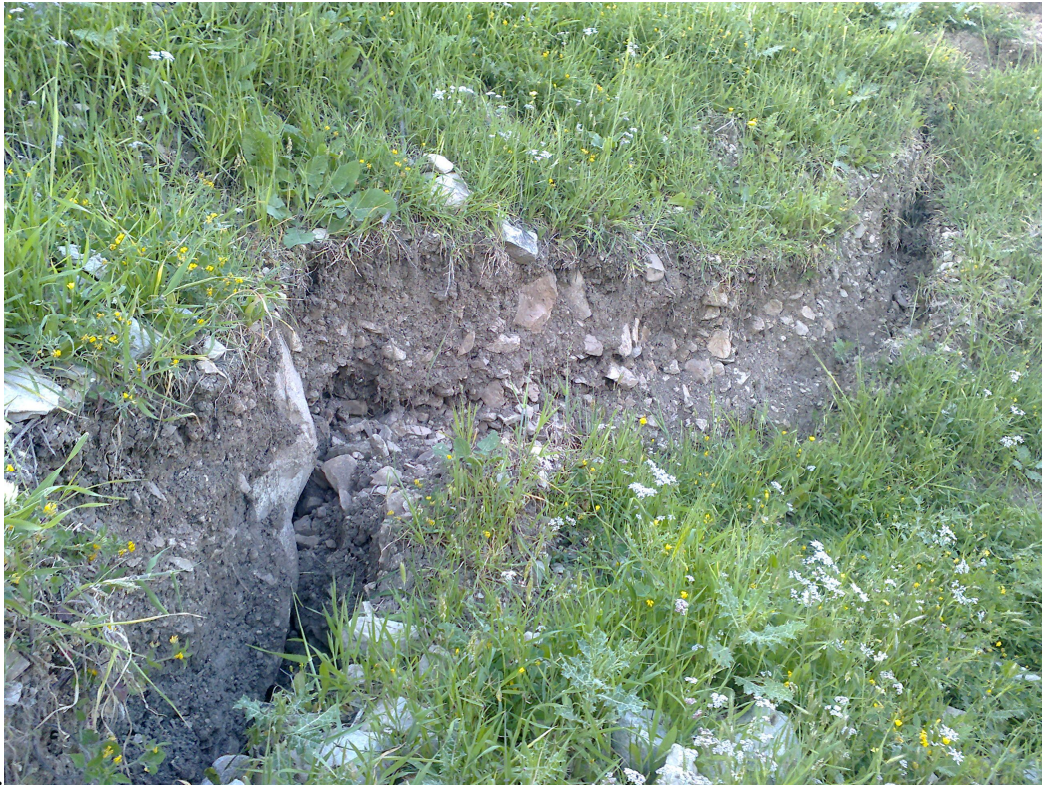
**Figure 2 : Local land sliding occurs yearly along Nablus – Al-Bathan Road.**

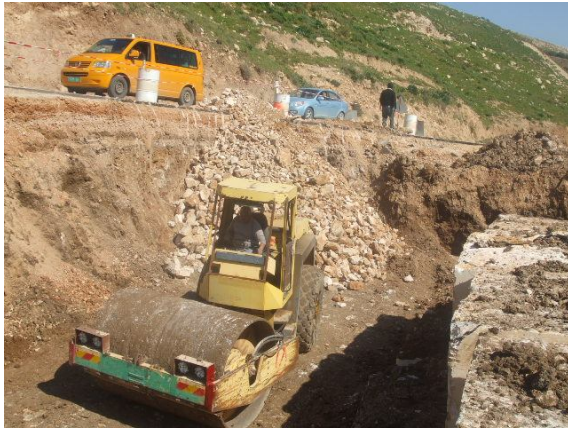
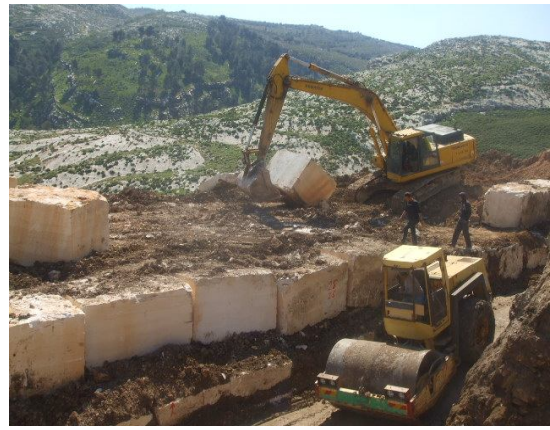
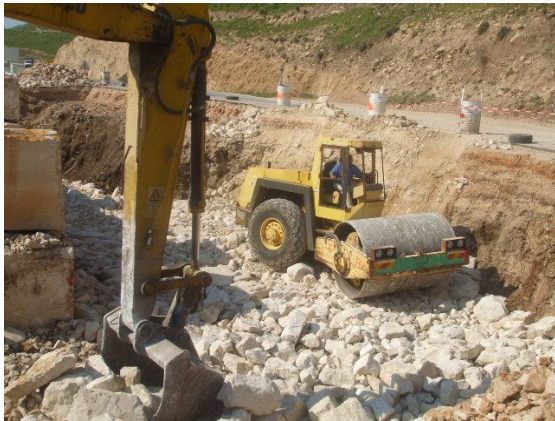
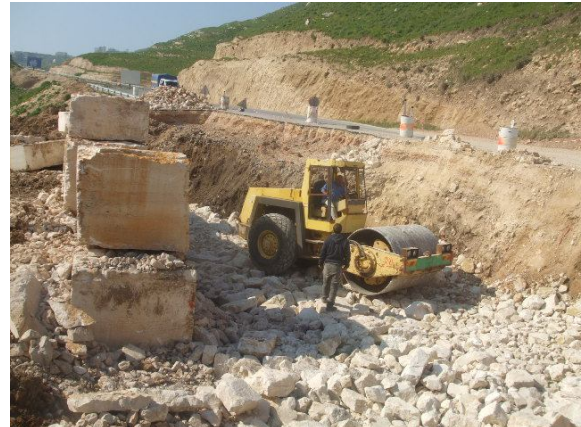
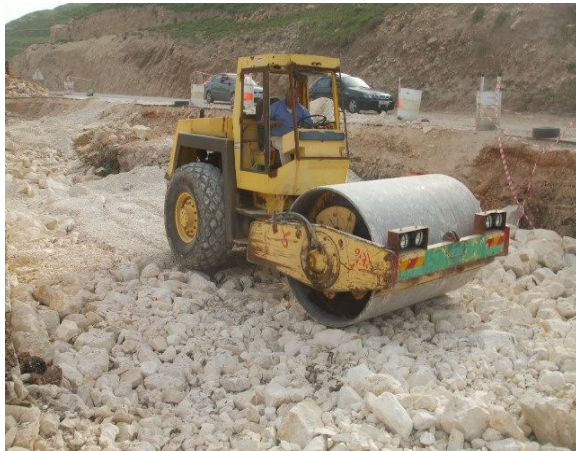
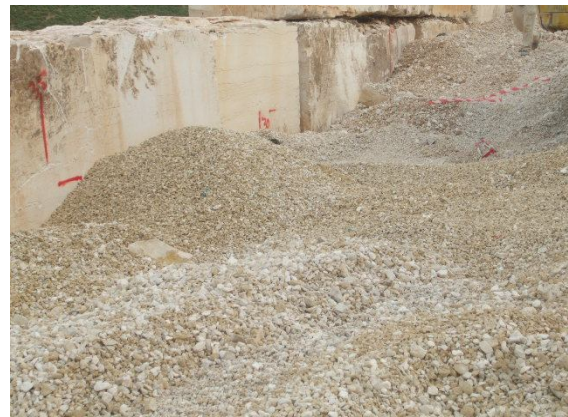
The rehabilitation conducted by PWHD - Nablus at station 2+100 was replacing the body of the of the road to a depth of about 4 m by several layers of boulders and base course and supporting the road by big boulders in the eastern side to a depth of about 6 m below the ground surface. This is shown in Figure 3.

**Figure 3: Remedial measures to fix the problem at station 2+100 in March 2012.**

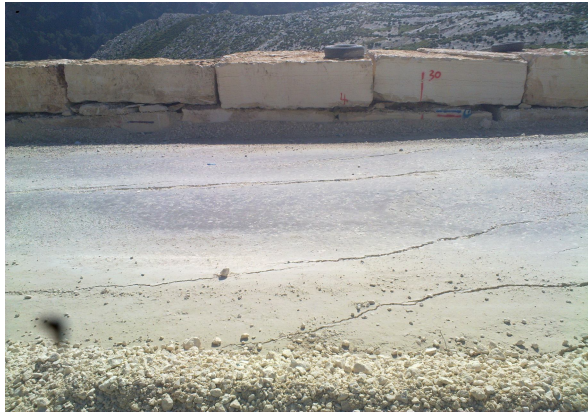
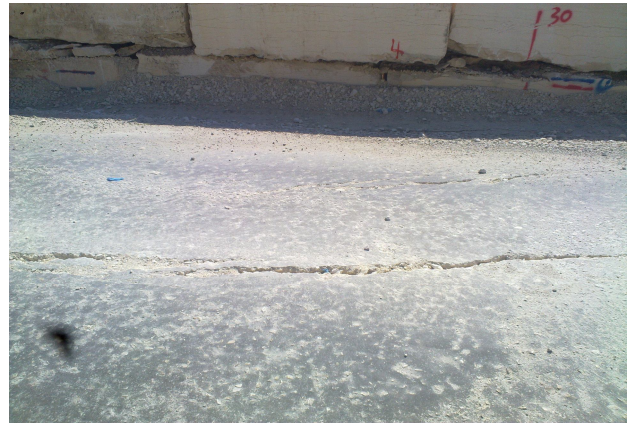
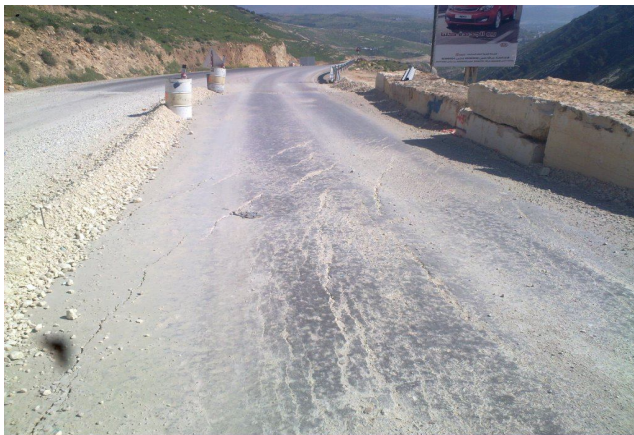
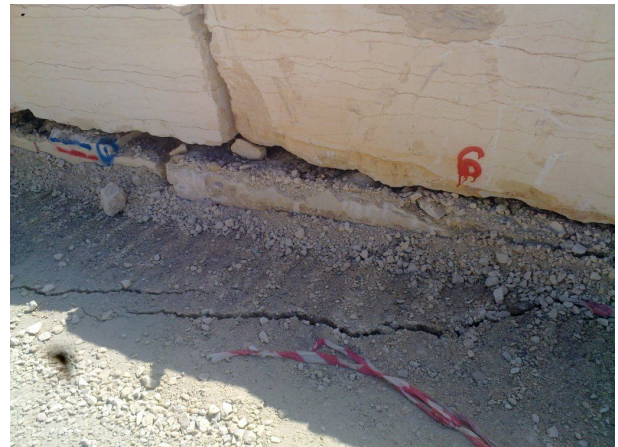
During the construction of the remedial measures large settlement occurred in the eastern part of the road next to the big boulders, and large sliding occurred in the eastern side of the road and extended down to the bottom of the valley. This is shown in Figures 4 and 5.

**Figure 4: Large settlements in eastern side next to big boulders.**

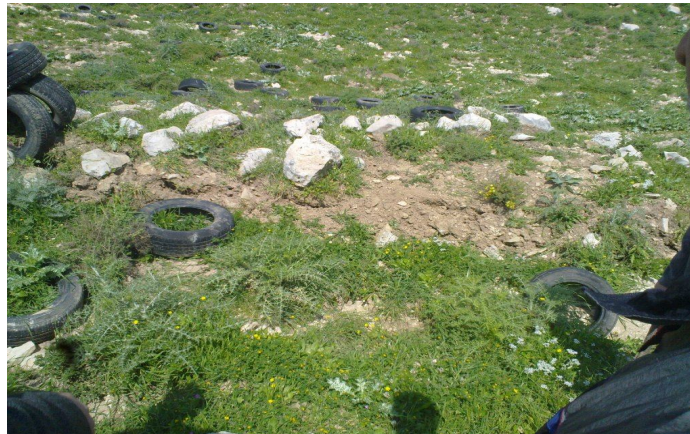
**Figure 5: Landsliding in eastern side of the road and extended down to the bottom of the valley.**

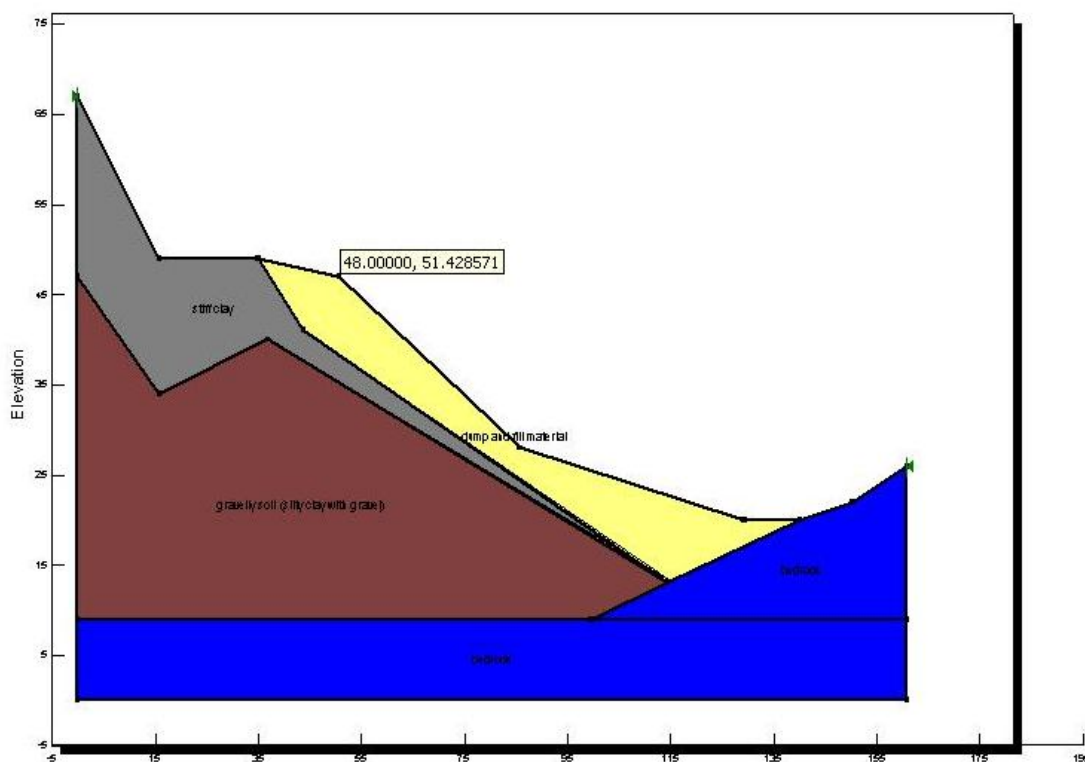
**Figure 6: Soil strata at Section No. 2 at station 2+100.**

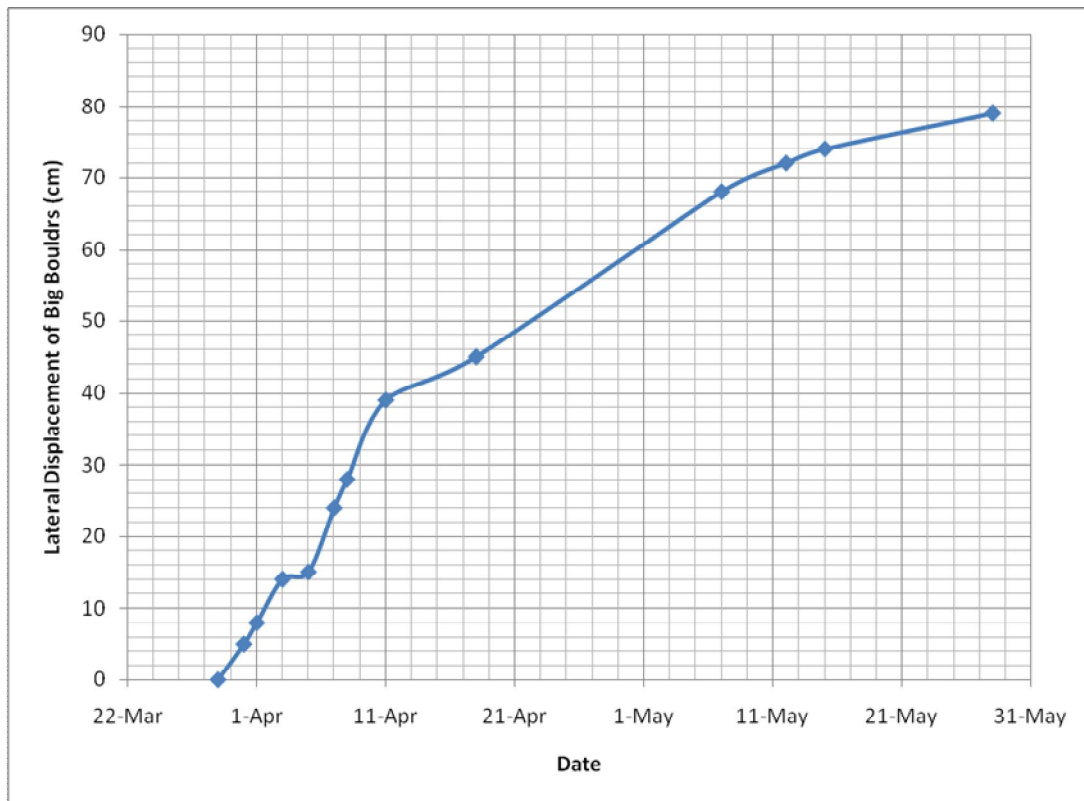
After the large displacement occurred at Station 2+100, horizontal (lateral) and vertical (settlement) displacements along the big boulders were recorded from 29/3/2012 to 28/5/2012 and are shown in Figures 7 and 8.

**Figure 7: Horizontal (Lateral) displacements along the big boulders.**

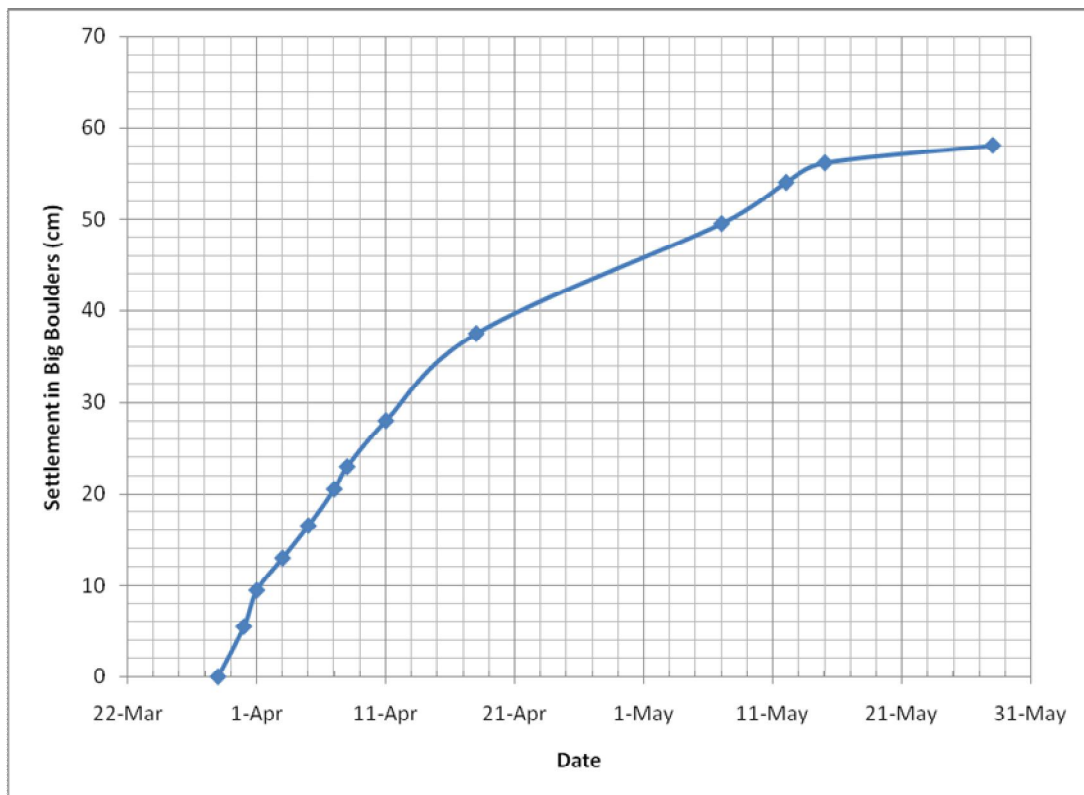
**Figure 8 Vertical (Settlement) displacements along the big boulders.**

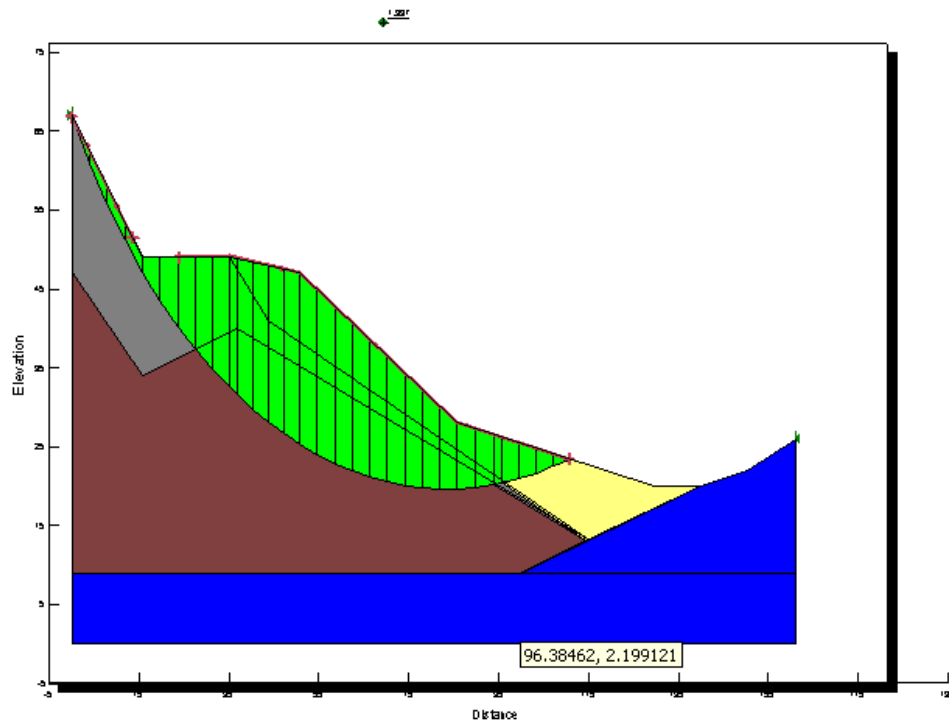
It is clear that the site in general suffers slope instability and hence, landsliding may occur at any moment especially in the eastern side of the road and in the fill and dump materials that support the body of the road. This is because the factor of safety found ranges between 1.06 and 1.52. The western side of the site has a factor of safety = 2.0 and hence it may be considered safe regarding that the soil properties do not change. However, this is not the case, i.e., the soil properties may be changed at this site due to weather conditions (rainfall). This will reduce the factor of safety and local landsliding may occur in western side of the site and actually several of them were noticed during the site visit.

Figure 9: Slope stability analysis for western side (Factor of safety = 2.0).

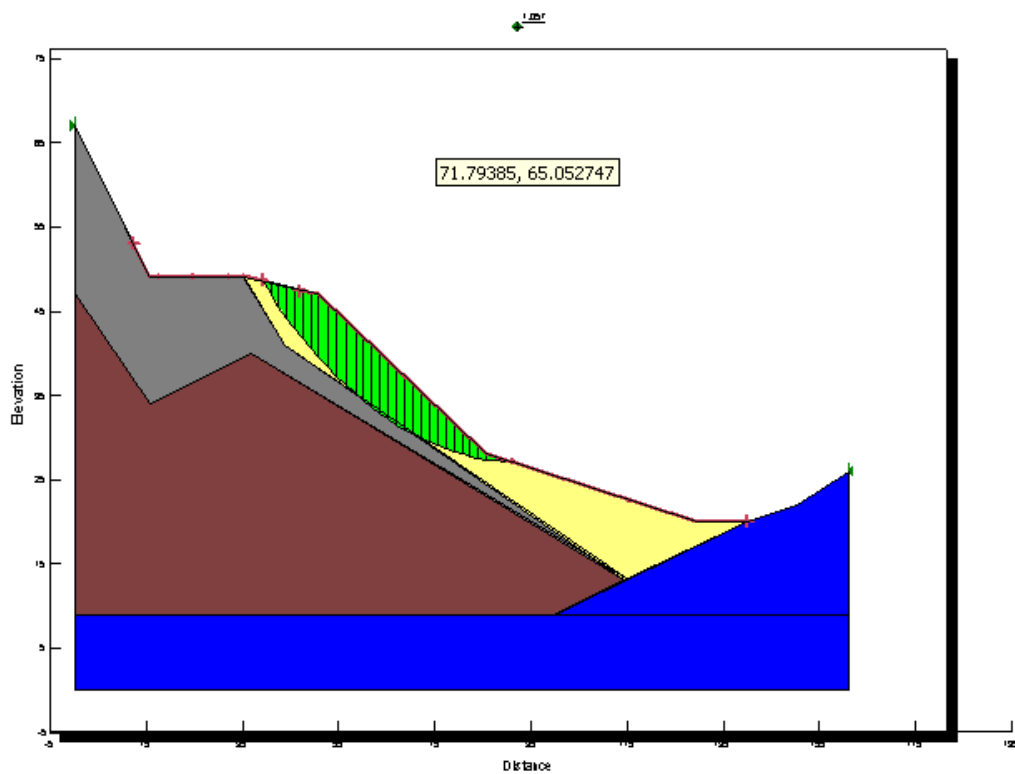
Figure 10: Slope stability analysis for eastern side in the fill materials (Factor of Safety = 1.06).

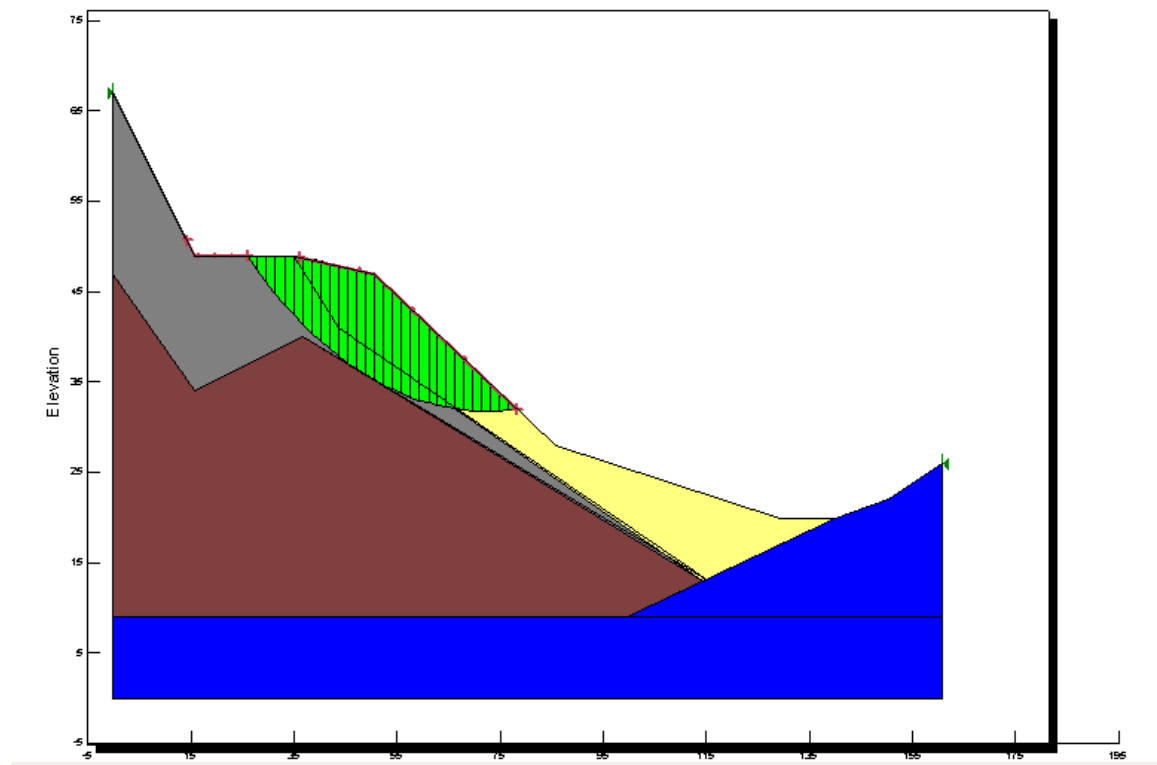
**Figure 11: Slope stability analysis for eastern side across the road (Factor of Safety = 1.52).**

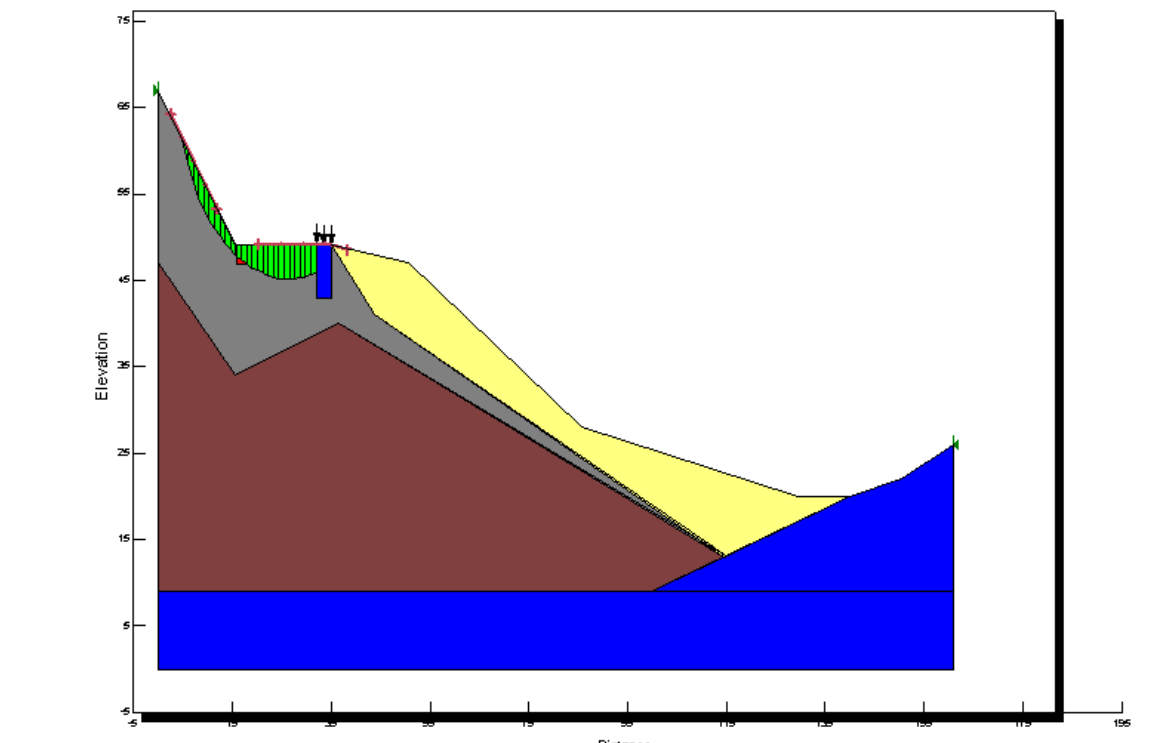
After improving the road by inserting 4 m thickness of several layers of boulders and base course and stacking big boulders at a depth of about 6 m from the original ground surface at the eastern side of the road to support the body of the road, the factor of safety for western side increased to become 3.9. However, the factor of safety for the eastern side decreased to become in the range of 0.98 to 1.02.

**Figure 12: Slope stability analysis for western side with soil improvement and big boulders (Factor of Safety = 3.9).**

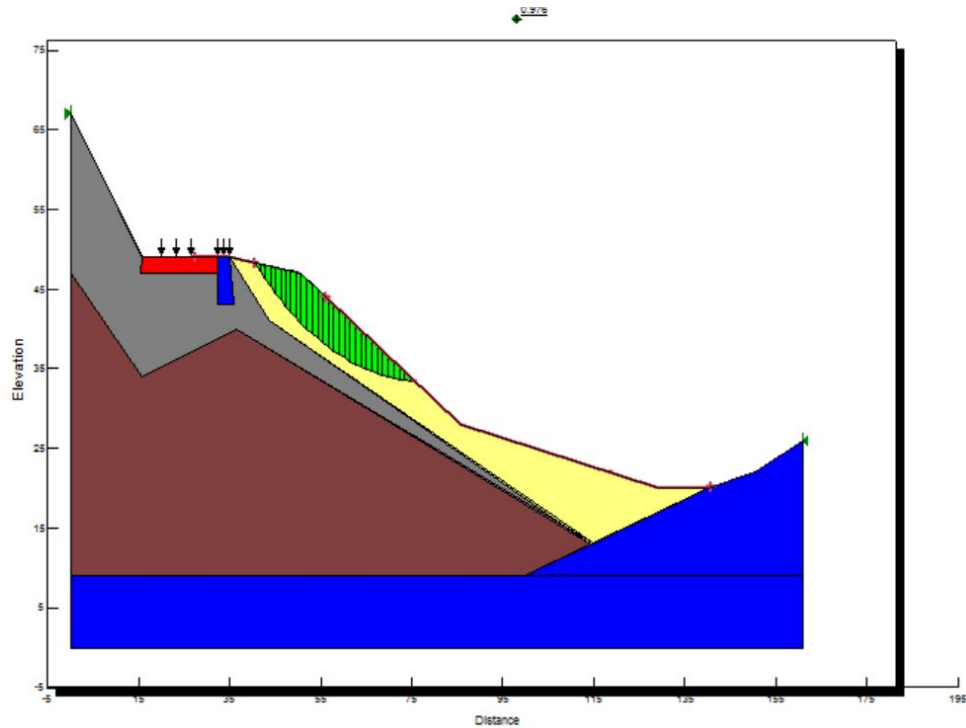
- Inserting the big boulders at Station 2+100, stabilize the western part of the road and side, however, reduced the factor of safety from 1.02 to 0.98 for the eastern side of the boulders.

**Figure 13: Slope stability analysis for eastern side with soil improvement and big boulders (Factor of Safety = 0.98).**

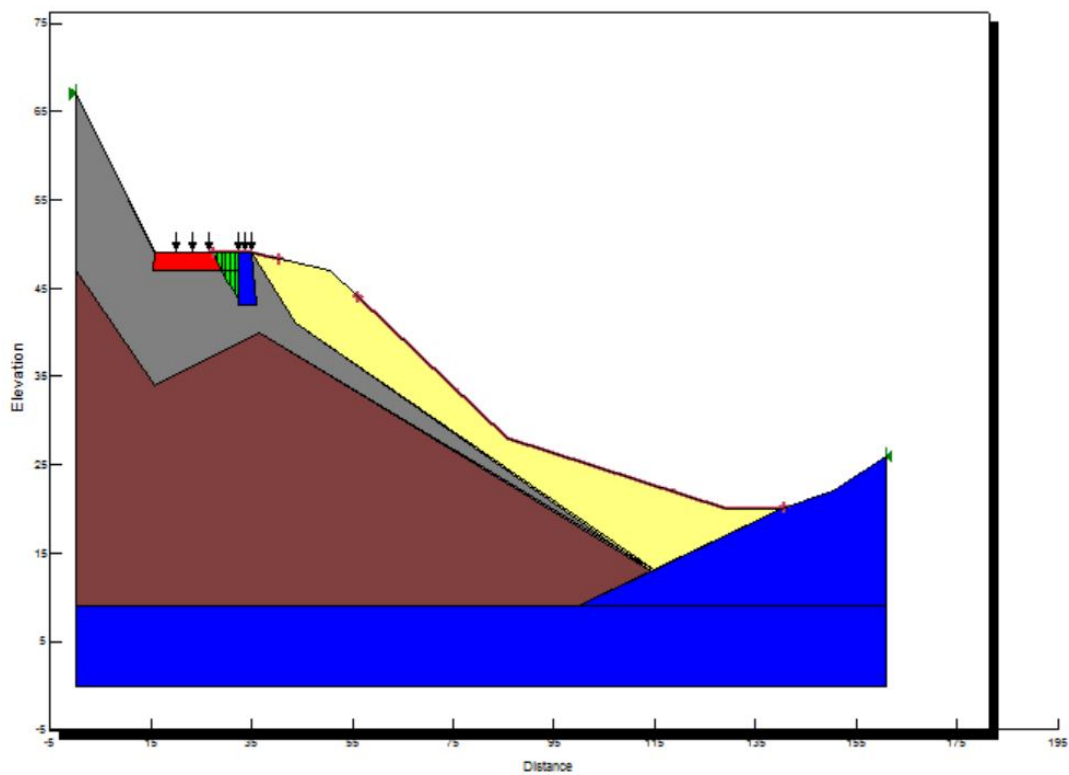
**Figure 14: Slope stability analysis for eastern side with soil improvement and big boulders behind the big boulder (Factor of Safety = 1.02).**

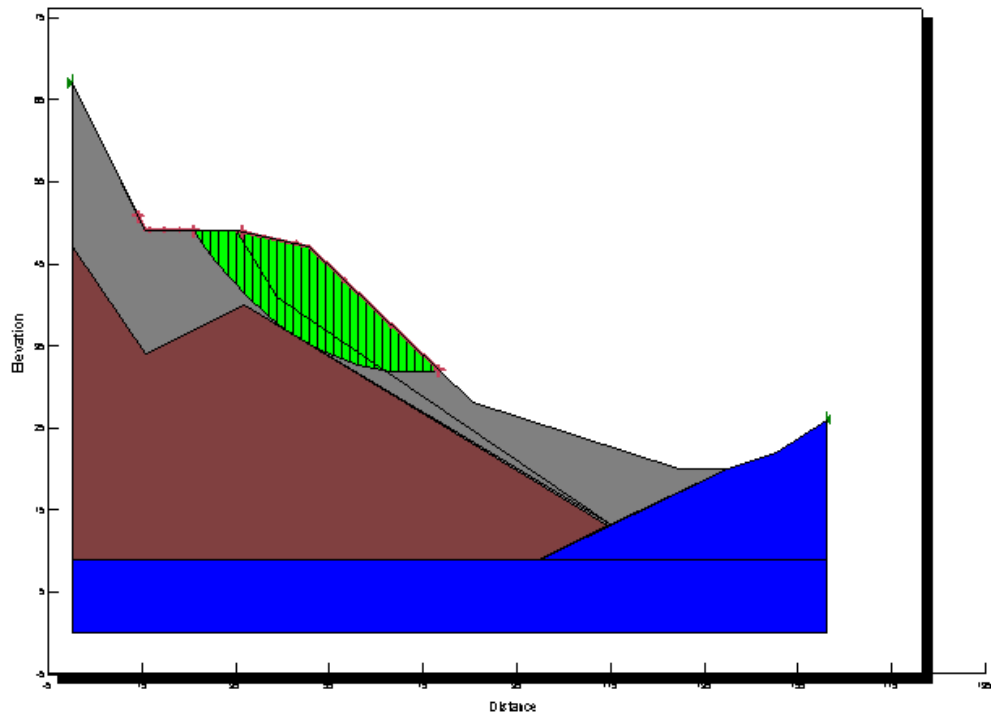
If the dump and fill soil to the east of the road is improved, for example by compaction or replacing the soil, then the factor of safety is increased to become 1.64. However, if more fill is added to eastern side down the valley, then the factor of safety increased more and become 1.88.

**Figure 15: Slope stability analysis for eastern side after improving the soil down the hill (Factor of Safety = 1.64).**

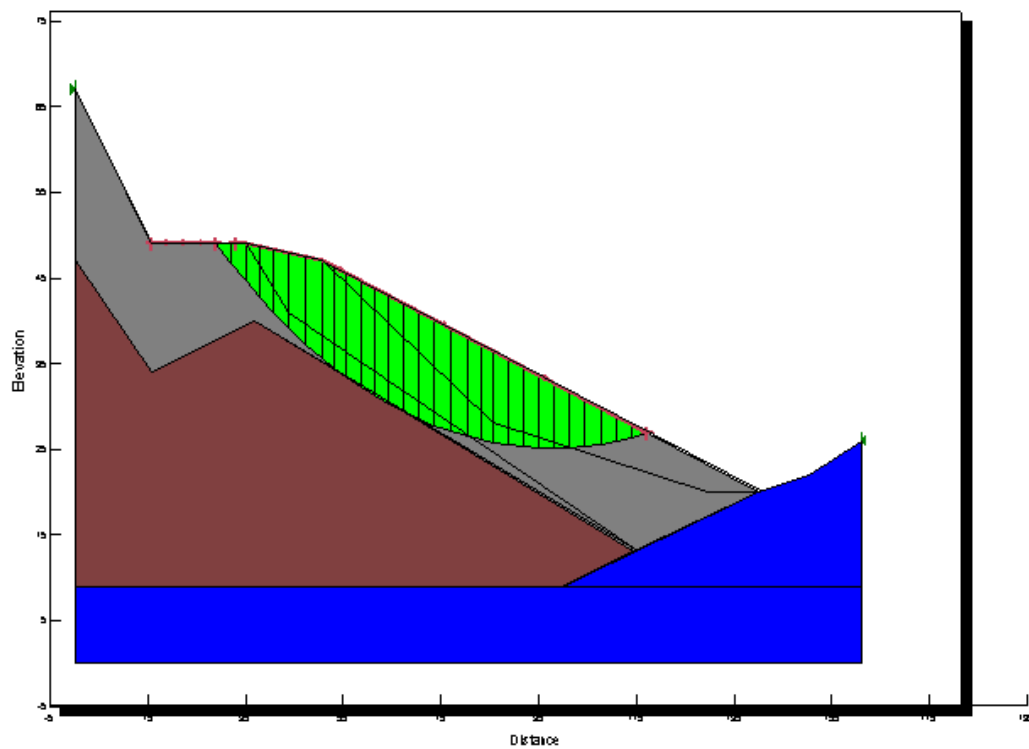
Figure 17: Improving and add more soil down the hill (Factor of Safety = 1.88)

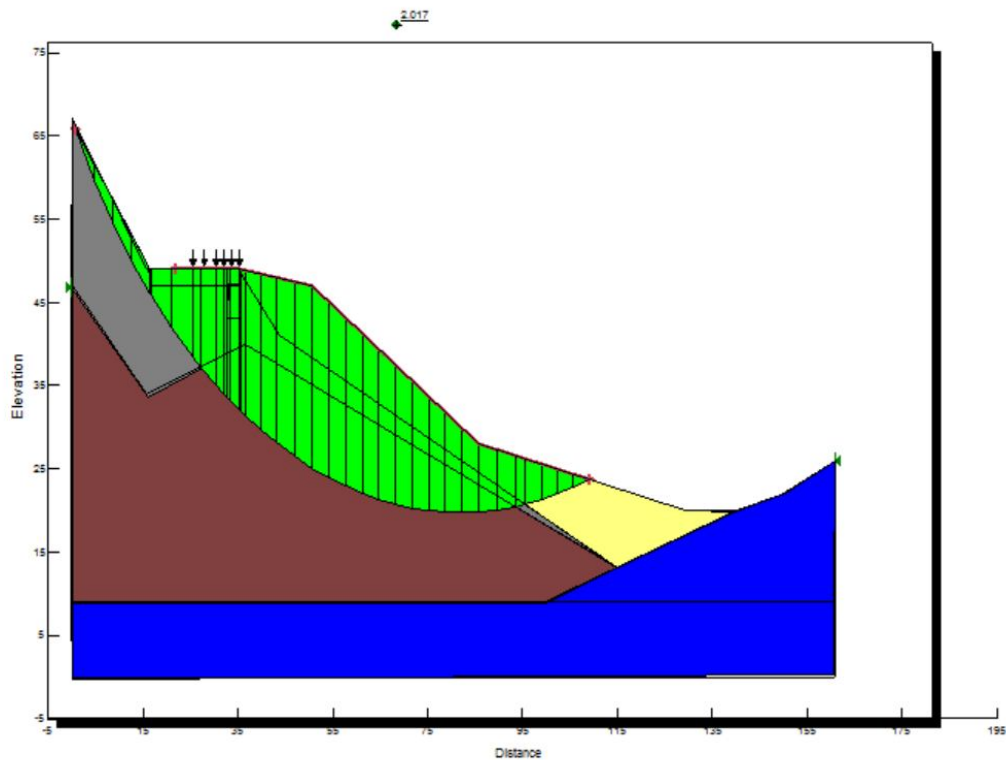
If big boulders is reduced by 2 m with original soil (no soil improvement), then the factor of safety for western side becomes 2 and factor of safety for eastern side becomes 1.71. If soil improvements are done for the dump and fill materials then the factor of safety for the eastern side becomes 1.86, and if more soil is added to the eastern side down the hill, then the factor of safety for eastern side becomes 2.64 and for the western side it becomes 4.5.

Figure 18 : Reducing the height of big boulders factor of safety = 2.02 upper part western side.

- ✓ Reducing the height of big boulders by 2 m.
- ✓ Surplus big boulders can be used to support the slope down the hill and in this case they should rest on good soil layer.

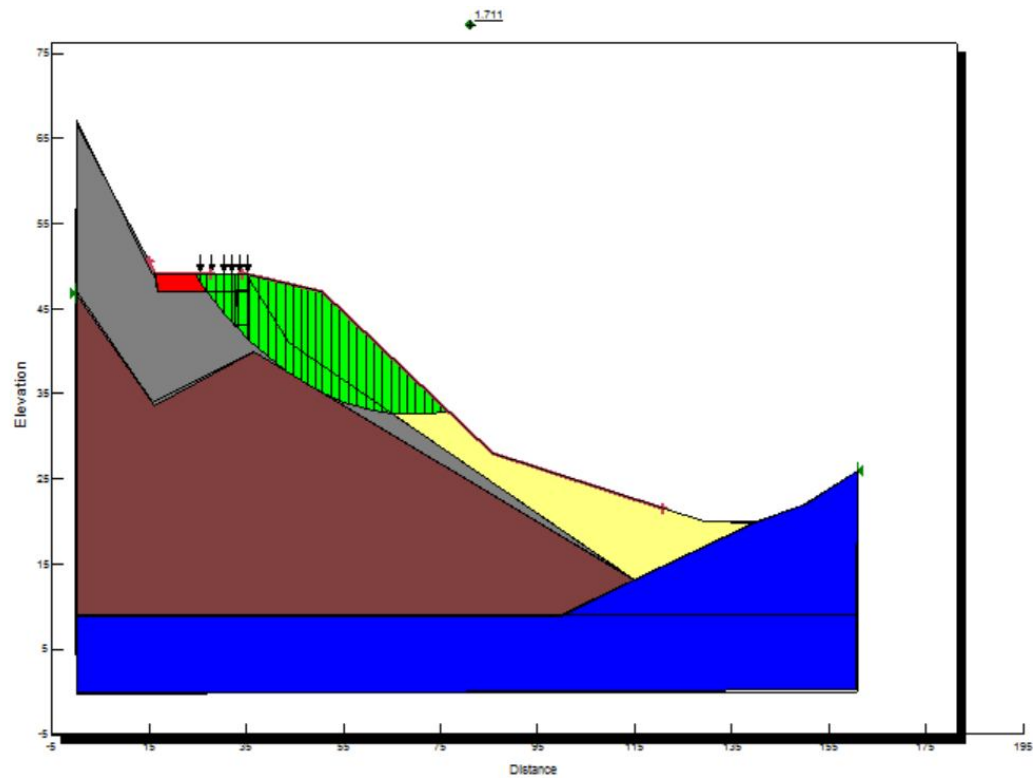
**Figure 19: Reducing the height of big boulders factor of safety = 1.71 eastern side**  
X

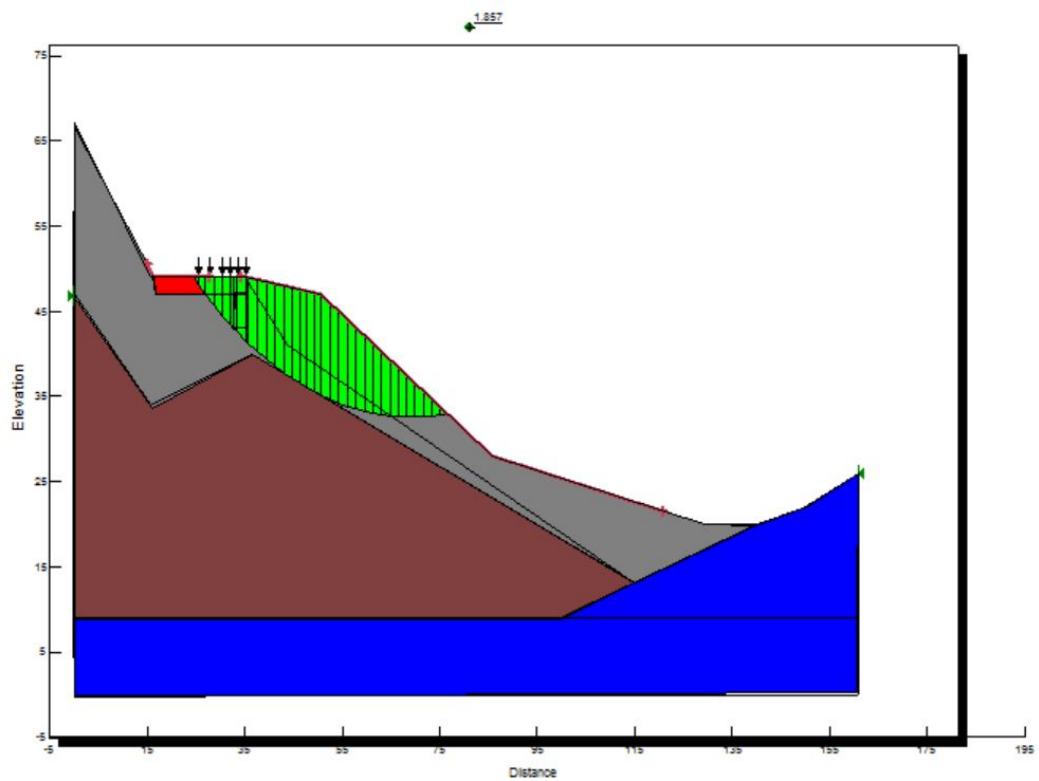
**Figure 20: Reducing the height of big boulders and improving the soil factor of safety = 1.86 eastern side**

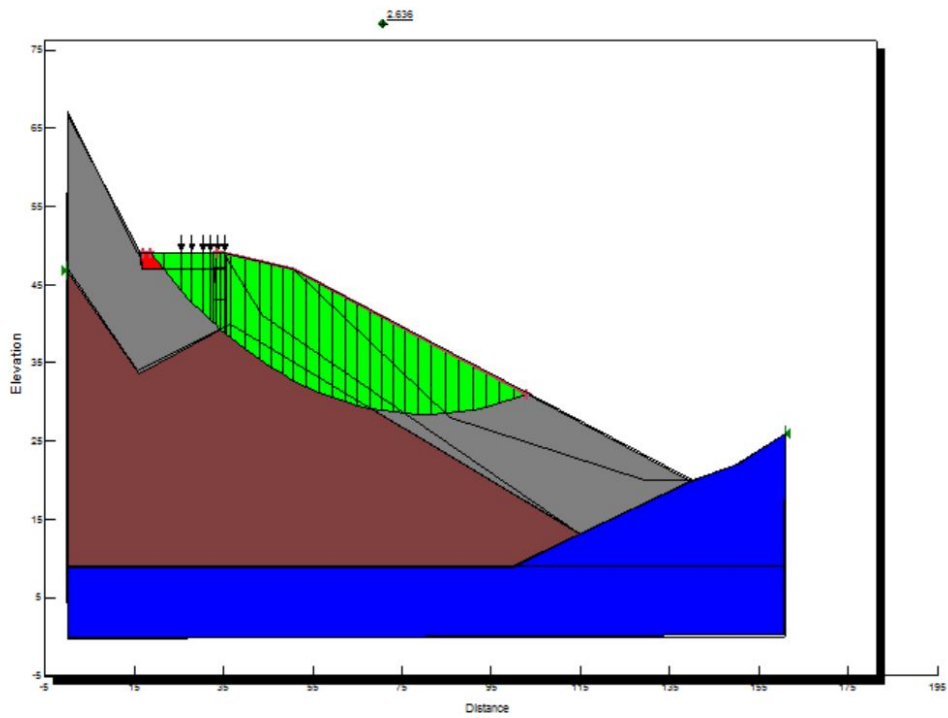
**Figure 21: Reducing the height of big boulders and improving the soil and more soil factor of safety = 2.64 eastern side**

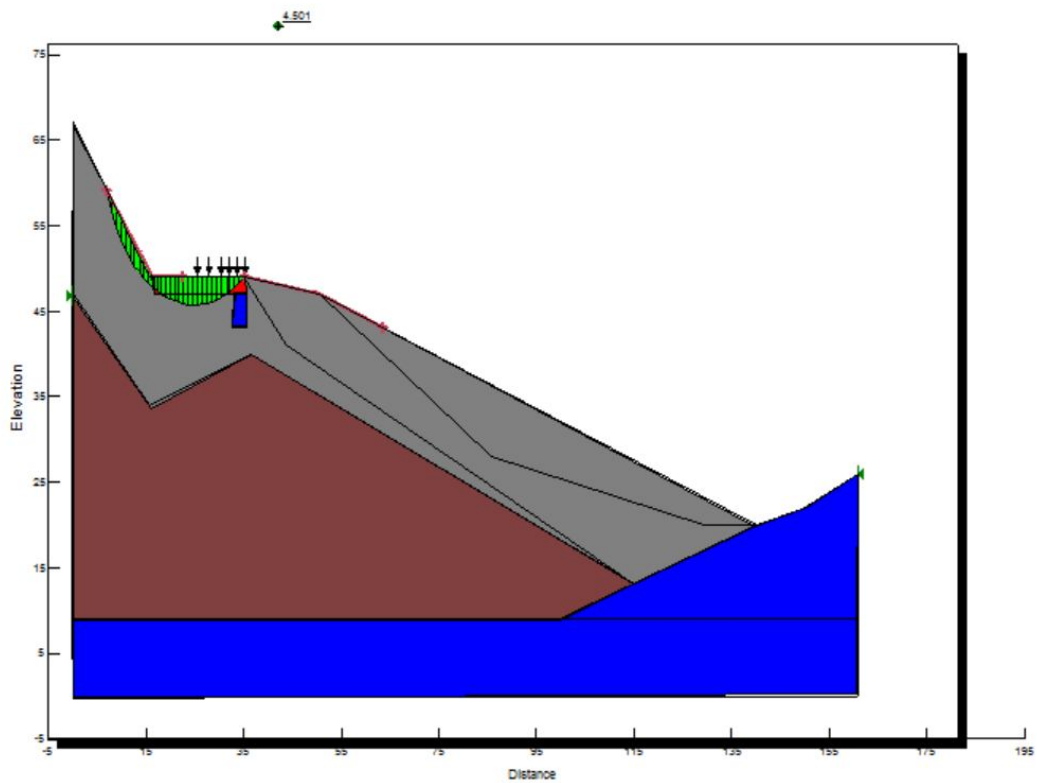
**Figure 22 :Reducing the height of big boulders and improving the soil and more soil factor of safety = 4.5 western side**

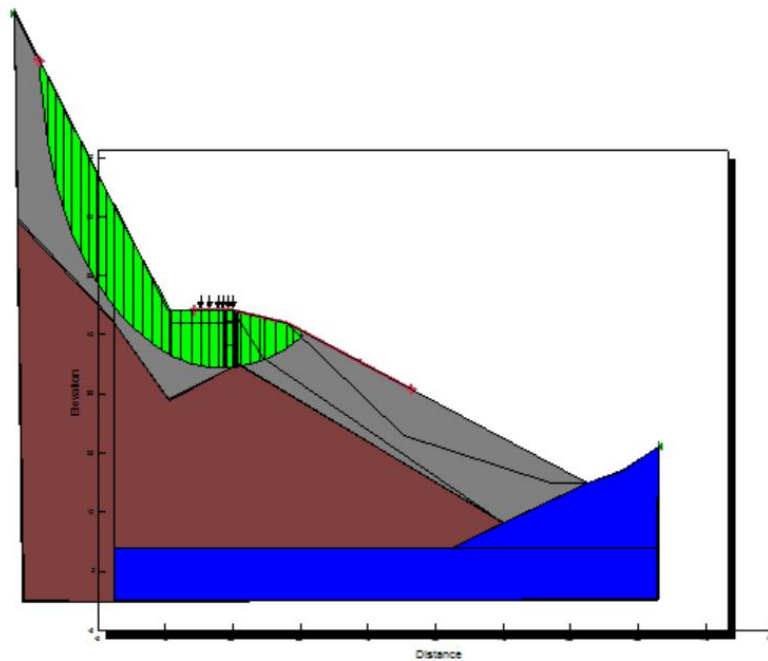
If the western side of the site extended to the west with a slope of 50 degrees, then the factor of safety of the western side would be decreased to become 1.1.

**Figure 23: Reducing the height of big boulders and improving the soil and more soil extended in the western side by 30 m horizontal and 35 m vertical the factor of safety = 1.1 western side soil.**

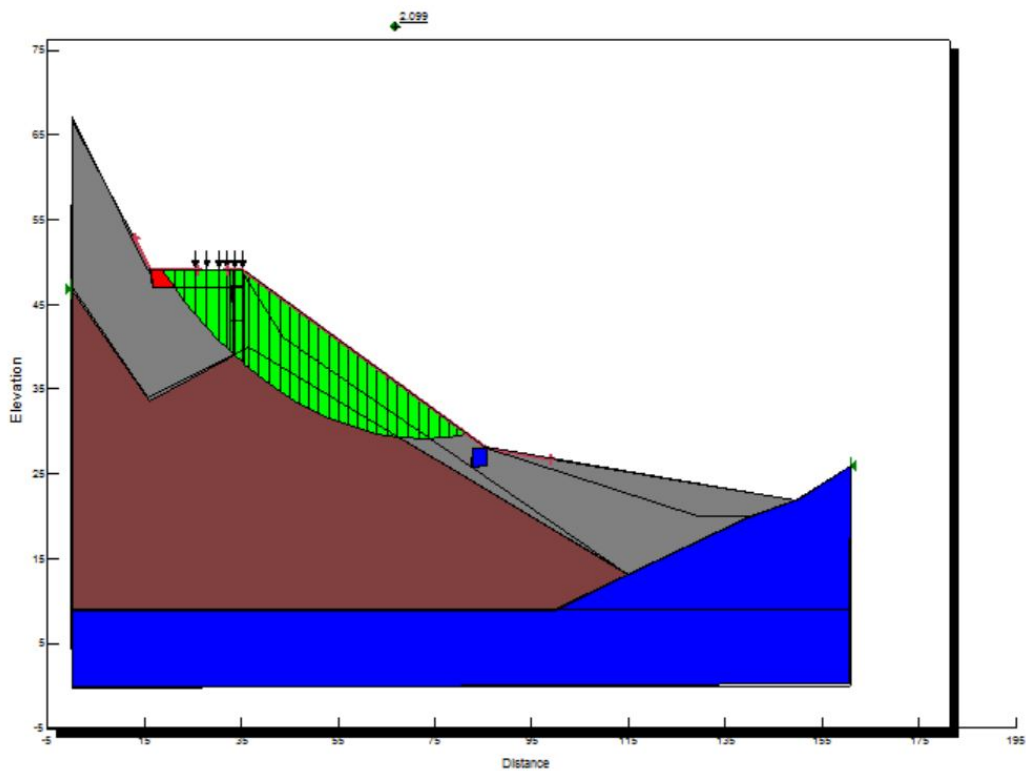
**Figure 24: Inserting 2 m of big boulders down the hill 50 m horizontally eastern of the top big boulders (Factor of safety = 2.1).**
