## Columns Replacement in the Church of Saint Fatima

Samir H. Helou\* Ph.D., P.E.

The town of Beit Sahour is one important biblical site in Palestine. Saint Fatima's Church built more than hundred years ago and reconstructed in the year 1949, is owned by the Latin Patriarchate and serves the small catholic community of the town. The church carries the name of Our Lady of Fatima which was the title given to the vision of the Blessed Virgin Mary when she appeared before three shepherd children in the town of Fatima in Portugal in 1917. In the summer of 2008 the parish priest of the Latin Congregation embarked upon a challenging and an aggressive project of changing the pillars within the church in order to widen the viewing angle to the altar area. The following is a detailed account of the design process together with the construction methodology that proved to be feasible in cost and effective in execution time. The sectional area of the new pillar is about a quarter of the original size. The success of the undertaking was measured by the extent of the induced cracks in the vicinity of each column. These cracks were either minimal or invisible. The section of the new pillars was

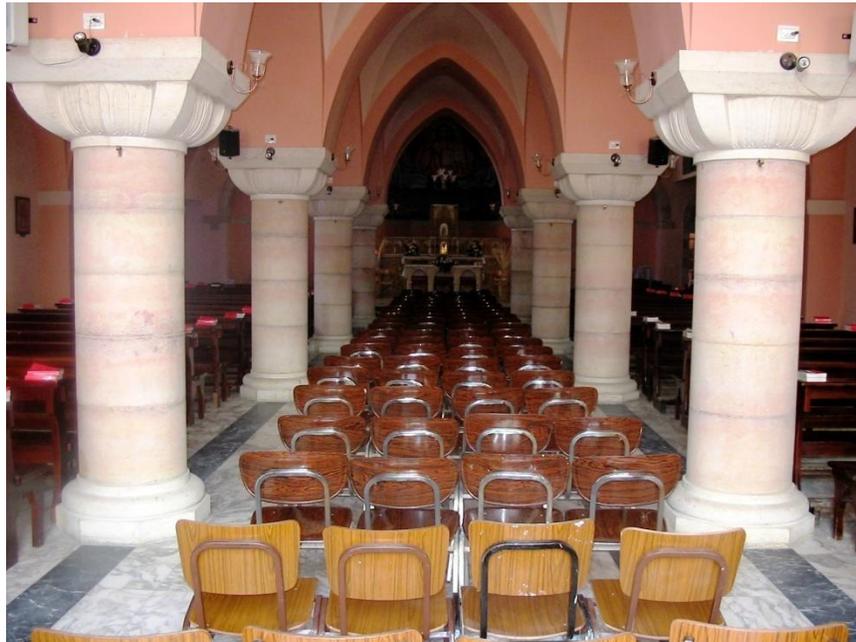
**Photo 1 General Interior Original View**

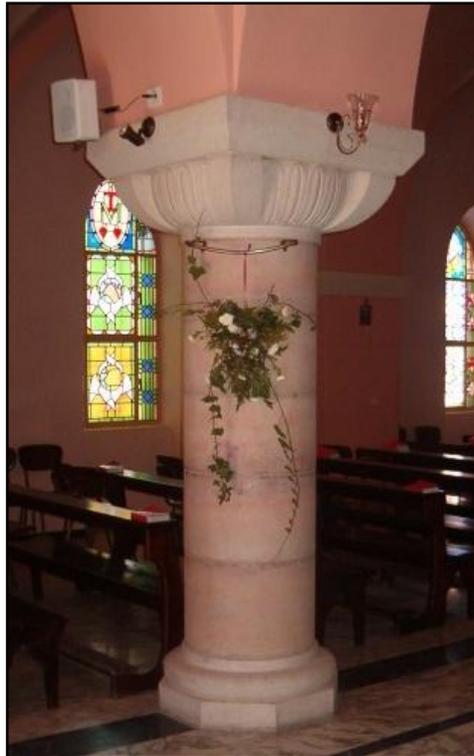
The original diameter of the columns within the Saint Fatima's Church stood at about 60 centimeters; their height is about 275 centimeters; they support a system of two way arches and vaults which characterize the masonry structure of the church. The exaggerated size of the columns blocked worshipers from viewing the altar area, as illustrated in Photo 1. The columns were made of five round blocks of pink native Palestinian Mizzi Yahoudi lime stone taken from Bethlehem area quarries. The top of the columns had an attractive hand carved crown and the bottom had an effective stone pad. Photo 2 is a snap shot for one of the targeted columns. The purpose of the engineering exercise was to replace the bulky masonry stanchions by new ones but of narrower diameter. The new stanchions would have a diameter of no more than 30 centimeters. The esthetics of the final delivered product was as important as the safety of the structure proper together with the safety of the church parishioners. The high risk involved in the undertaking had to be very well considered.

**Photo 2 The Original Column**

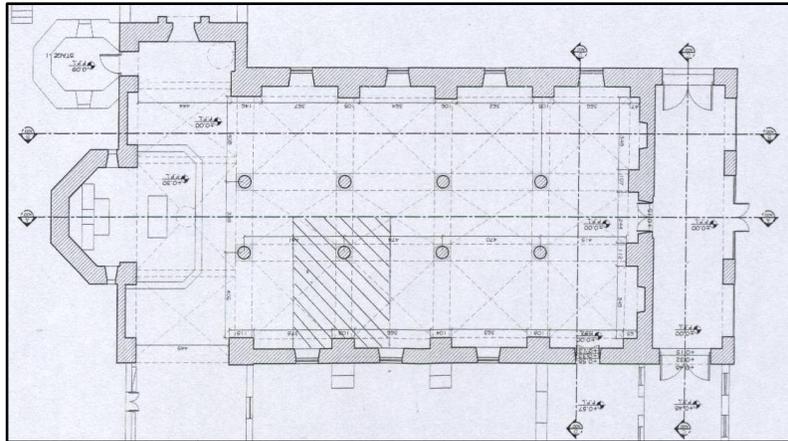
Figure 1 The Floor Plan of the Church

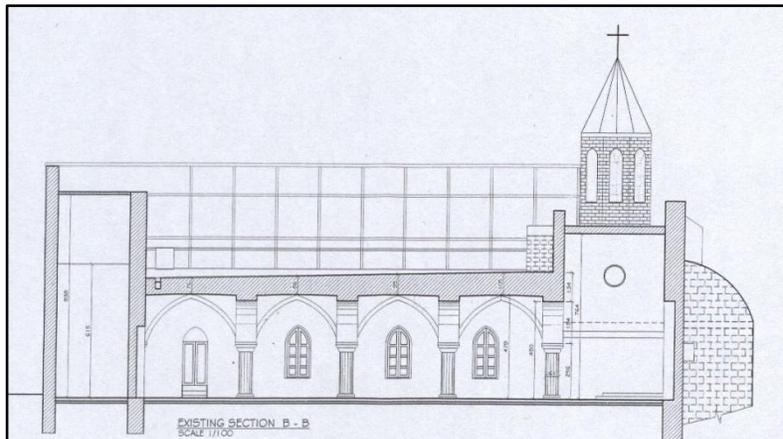
Figure 2 A Longitudinal Section

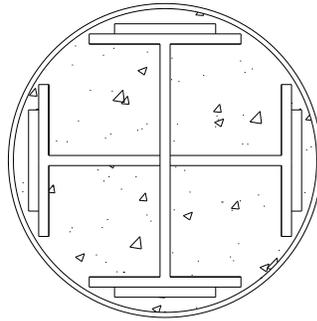
The column was expected to be subject to vertical axial loadings; however accidental eccentricity of 7 centimeters due to the possible unsymmetrical loading in either direction was assumed for added safety. This could be perpetual or transient happening during construction. The induced bending moments in the x and the y directions were estimated at 42 KN-m. The section as defined in the computer model is shown in Figure 3.

The proposed section was a composite one made of one Hollow Steel tube of 324 mm diameter and of 8 mm wall thickness holding 2 orthogonal UB 254x146 sections with 4 stiffener plates of 100x20 mm welded to all flanges. One UB section had to be cut along the middle for obvious reasons. The rest of the volume was filled with concrete. The column had a round steel base plate of 350 mm diameter and of 20 mm thickness. The column was topped by a 30 mm round steel plate. Good quality concrete adds to the durability of the section, provides confinement to the steel elements in addition to the added compressive strength that it provides.

**Figure 3 The Section of the New Column**

Area = 330.2 cm <sup>2</sup>	R <sub>major</sub> = 9.18 cm
I <sub>major</sub> = 27,835 cm <sup>4</sup>	R <sub>minor</sub> = 9.16 cm
I <sub>minor</sub> = 27,715 cm <sup>4</sup>	E = 200,000 MPa
Z <sub>major</sub> = 7,110 cm <sup>3</sup>	F <sub>y</sub> = 25 MPa
Z <sub>minor</sub> = 7,071 cm <sup>3</sup>

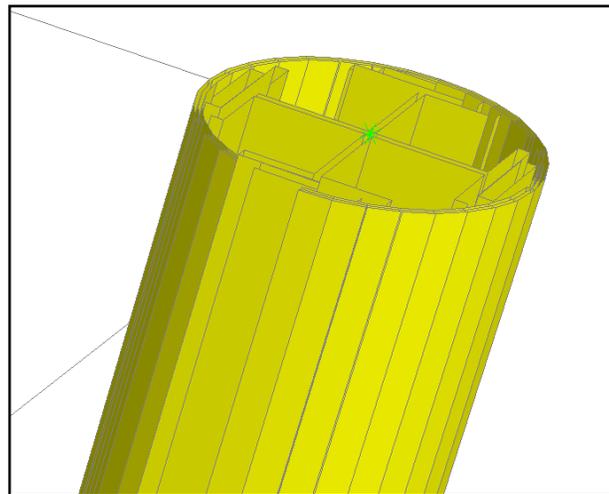
The Finite Element Program SAP2000 was judged suitable for the present analysis undertaking. This was primarily based on the availability of its Section Designer feature. A one dimensional column element was constructed with 2 loading cases and one load combination. The section was entered into the model via the section designer wizard. This was due to the fact that no standard section was readily available to meet the existing conditions but a built up section was the prudent choice. The prototype column was envisaged to be topped by a steel plate and another base plate at the bottom end. Heavy loads and friction on the end plates were expected to render the column as fixed at both ends. The Allowable Stress Design (ASD) method was the selected course of action. This was in spite of the high dead load to live load ratio; in the present undertaking conservatism was judged necessary. Therefore the bottom end was modeled as a pinned end while the upper one was modeled as a roller in the z direction while it was restrained in both the x and the y directions. This is illustrated in Figure 4.

**Figure 4 The Mathematical Model**

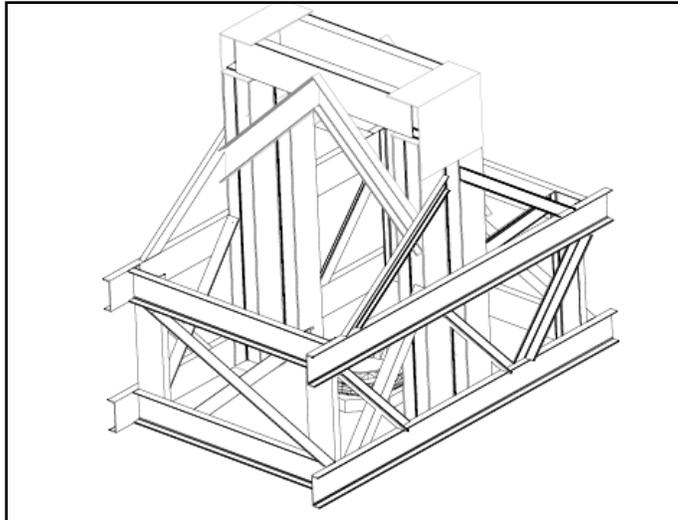
With the new column comprehensively designed and ready for mounting, the column replacement exercise hinged upon the removal of the existing column with absolutely no damage inflicted to the main church structure. Any small damage would be irreversible, would pose tremendous hazard and would render the premises unsafe. The load resting on the column had to be effectively shored. Figure 5 and Figure 6 show the steel framed shoring system. Its design and analysis were meticulously accomplished using SAP 2000. The criterion followed in the rigorous analysis undertaking was to guarantee minimal, if any, deflection under dead load action on the directly supporting elements. Moment resisting braced elements and truss elements were specified together with appropriate shear or moment connection patterns using 20 mm A325 bolts. Impact loading under any circumstance was ruled out. Furthermore, the shoring structure had to be mobile, light and fully stable.

Figure 5 A Perspective View of the Temporary Shoring System

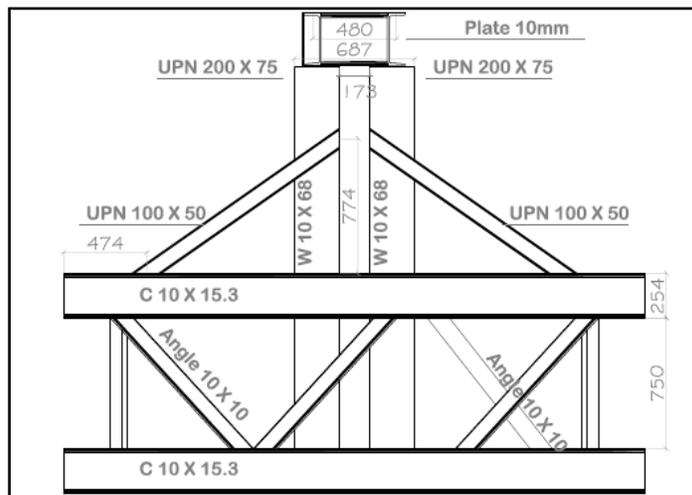
Figure 6 Details of the Shoring System

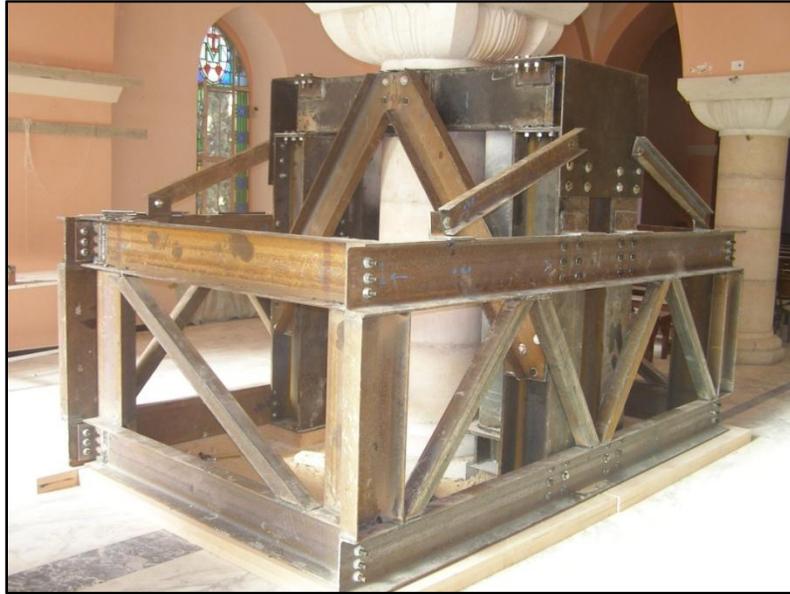
- d. The temporary supporting steel structure was to be effectively and promptly put in place as shown in Photo 3. This is a rigid frame, with braces modeled as truss elements, designed to yield minimal deflection under the applied dead load. Connections made of 20 mm A325 bolts, allowed for system mobility.

**Photo 3 The shoring steel frame**

It was apparent that the bases as well as the crowns of the church columns were made of quality pink stone with elegant carvings. This observation implied that the capital stones were either one piece extending from one end to the other or the crowns and the bases were made up of two adjacent stone pieces. These elements were to remain in place. Each column was comprised of five round stones of 60 centimeters diameter. The architectural layout and the vertical section around a typical column give a good estimation of the loads involved. The loads that each column supported included a dead load, a minimal live load as well as a minimal snow load as the town of Beit Sahour is seldom known for severe snow storms. A typical tributary area and a relevant section from which loads were quantified are shown in Figures 1 and 2. While the masonry column was being replaced an effective temporary shoring system was put in place. The operation involved the transfer of loads in two stages. The new column had a composite section made of structural steel imbedded in concrete, shown in Figure 3. Chiming with steel chims was the suggested method for establishing snug anchor for the newly mounted column. Extra attention to details and comprehensive safety precautions had to be taken; these included, but were not limited to, skilled workers and proper insurance coverage. Furthermore, perhaps more intricate in design and construction was devising a moveable shoring system capable of supporting the church ceiling while the columns were being replaced. This was accomplished by the versatile rigid steel frame shown in Photo 3.

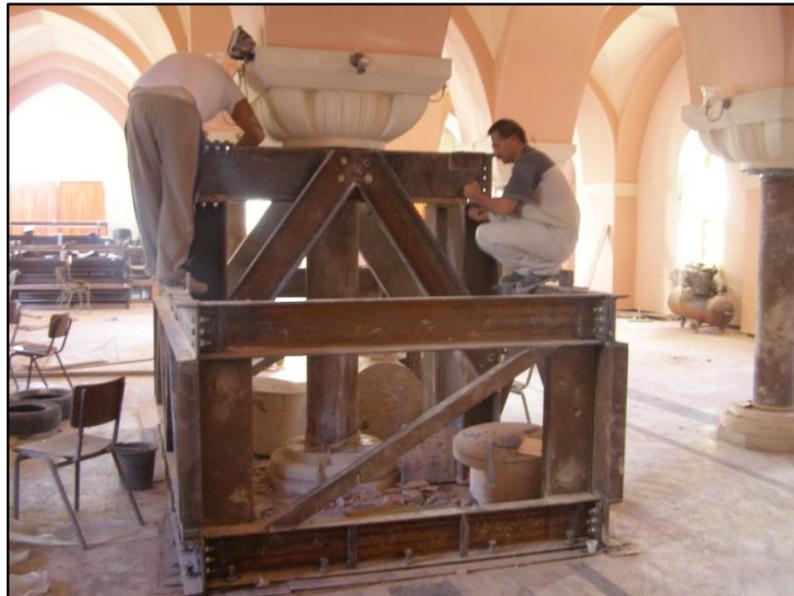
**Photo 4 The Shoring Steel Frame**

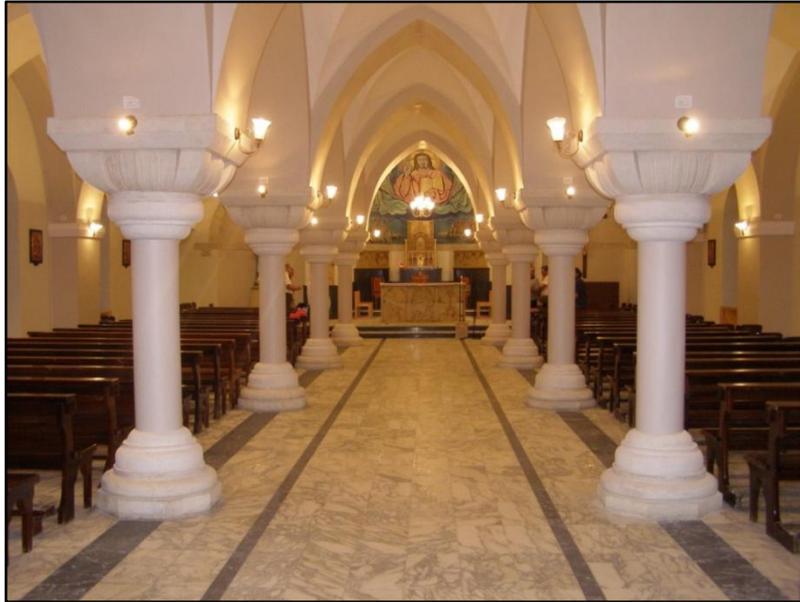
- j. Painting and decorating the body of the new stanchion to make it in harmony with the rest of the church architecture was the final touch to the general esthetics of the final delivered product. This is shown in Photo 5.

**Photo 5 The New Interior View**

The success of the operation could be measured by the extent of crack widths of the gravity arch and the adjacent church walls. Such cracks were either minimal or were totally absent. The church went back to serve the community of parishioners, albeit with a better interior climate.
