DEAD SEA EARTHQUAKE OF 11 FEBRUARY 2004, ML 5.2: POST EARTHQUAKE DAMAGE ASSESSMENT IN THE WEST BANK, PALESTINE

J. N. AL-DABBEEK AND R. J. EL-KELANI

*Earth Sciences and Seismic Engineering Center (ESSEC),
An-Najah National University, Nablus, P.O. Box 707, Palestine
E-mail: seiscen@najah.edu*

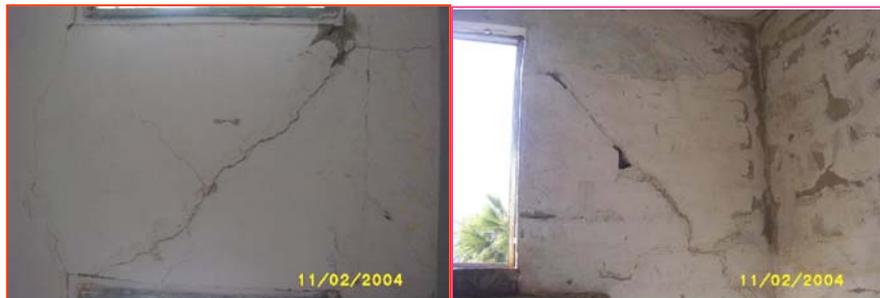
Figure 2. Reinforced Concrete Buildings (Aqraba School).

Three old schools suffered moderate to substantial damage: slight to moderate structural damage and moderate non-structural damage (damage grade 3), see figure 2.

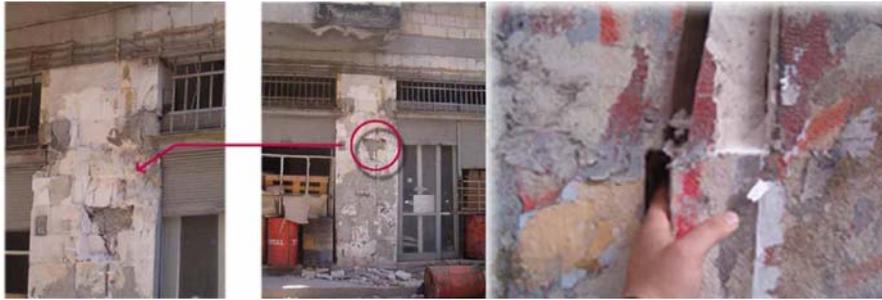
Figure 3. Masonry Building (5 floors), crack patterns in masonry pillars and expulsion of blocks.

The damages that had been occurred had usually been at zone of pre-existing weakness, in the light of the post-earthquake investigations the effected masonry and old masonry buildings suffered with the following damages: crack patterns in masonry pillars; slippage between the blocks; expulsion of blocks in poor mortar stone masonry; large permanent deformation (due to the seismic action); corner detachment; a flat vault's collapse; detachment between few perpendicular walls (in a corner); and crushing in masonry pillars.
