# **Study of Slope Instability of Nablus – Al-Bathan Road**

**Stations 2+100**

Construction and Transportation Research Unit  
Urban Planning and Disaster Risk Reduction Center  
An-Najah National University

**June 2012**

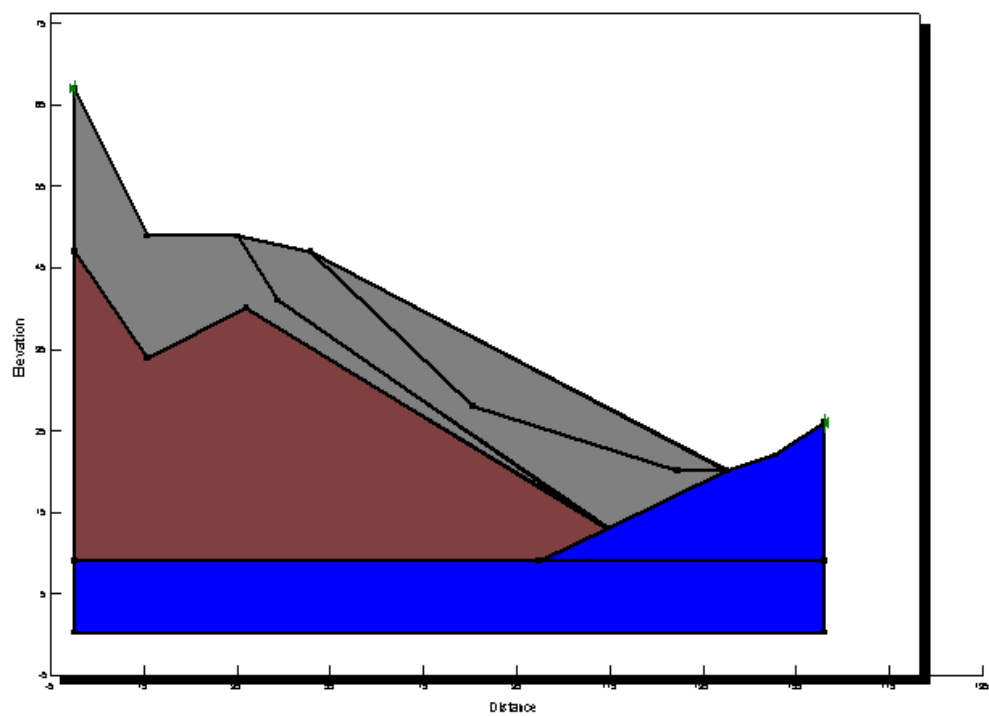
No.	Conditions	Description	Factor of Safety		Notes
			Western Side	Eastern Side	
1	Base Case	Original soil strata without any soil improvement.	2.0 (Figure 9)	1.06 (Figure 10)  1.52 (Figure 11)	Figure 10 across the dump and fill material. Figure 11 across the road.
2	Road body improvement and big boulders	Improving the body of the road to a depth of 4 m and inserting big boulders to a depth of 6 m.	3.9 (Figure 12)	0.98 (Figure 13)  1.02 (Figure 14)	Figure 13 across the dump and fill material. Figure 14 across the road.
3	Improving the dump and fill soil	Replacing the dump and fill soil or mixing it with boulders (improve it) to increase its shear strength.		1.64 (Figure 15)	
4	Improving the soil down the hill and add more soil	Replace or improve the dump and fill soil and adding more soils down the hill to increase stability without big boulders.		1.88 (Figure 17)	Figure 16 shows the soil to be added down the hill in the eastern side.

**Figure 16: Improving the soil down the hill and add more soil.**
