MRI Artifacts

Magnetic resonance imaging (MRI) has become more and more frequently used in medical imaging diagnosis in the recent years. Radiologists and technicians working at these systems are relatively often confronted with image artifacts related to the radiowave with strong magnets in the scanner. Numerous artifacts are associated with MR scanning.¹⁻⁴ With an understanding of their cause, many may be corrected, minimized, or avoided, either at the source before data acquisition or at the reconstruction stage after data acquisition. This requires familiarity with the scanner design, the theory of operation and image acquisition. Therefore, this article presents the most relevant artifacts occurring in MRI, providing physical background on the formation of artifacts and suggesting strategies to reduce or avoid these artifacts. Motion-related; para-magnetic; phase wrap; frequency; susceptibility; clipping; chemical shift and zebra artifacts are the most frequent MRI artifacts.

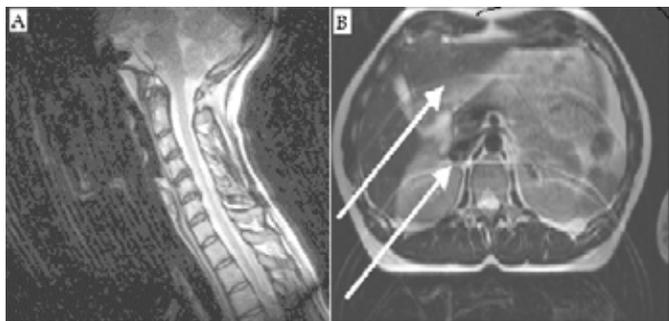
Fig. 1. Motion artifact
A. Sagittal T2-weighted image of the cervical spine with pulsation artifact.
B. Axial image of the abdomen showing motion artifact.

Motion-related artifact: Motion artifacts occur as a result of movement of tissue during the data acquisition period due to respiration, pulsation or motion, through the gradient magnetic field, hence acquiring an additional phase shift. They are manifested as signal misregistrations in the phase encoding direction than the readout direction because the encoding of phase by GPE occurs prior to signal detection.⁵ An example of motion artifact is clarified in Figure 1.

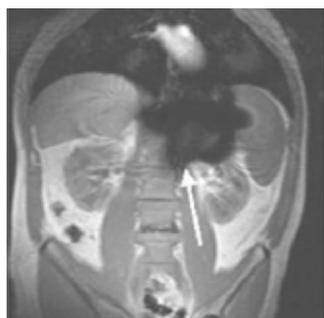
Fig. 4. Coronal MRI image of the abdomen showing susceptibility artifact.

Susceptibility artifact: Susceptibility is the ability of substances to be magnetized, e.g. iron in blood.⁸ Susceptibility artifacts are caused by local magnetic field inhomogeneity. Tissues (cortical bone) or air-filled organs (lungs or bowel) contain little polarizable material and have very small susceptibility values. Soft tissue has a greater degree of polarization and a larger susceptibility. At the interface between soft tissues and the area of different susceptibility, a significant change in the local magnetic field is present over a short distance, causing an enhanced dephasing of the protons located there (Fig. 4).

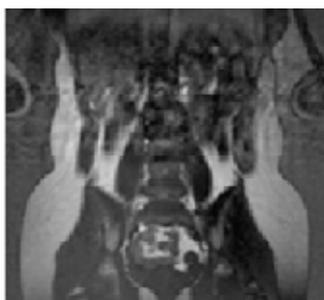
Fig. 5. Coronal MRI image of the pelvis showing clipping artifact

Clipping artifact: Signal clipping or 'over flow' occurs when the receiver gain is set high during the pre-scan producing insufficient digital sampling of the echo and representing low signals incorrectly on the image. T1 sagittal imaging of the cervical spine is a common site for this artifact. Truncations occur in the phase direction only (Fig. 5). Increasing the number of phase encoding steps may compensate for this artifact.
